Frey Farm Landfill

Stage 1 Visual Landscape Synthesis Plan

Annual Status Update

Manor Township, Lancaster County, Pennsylvania

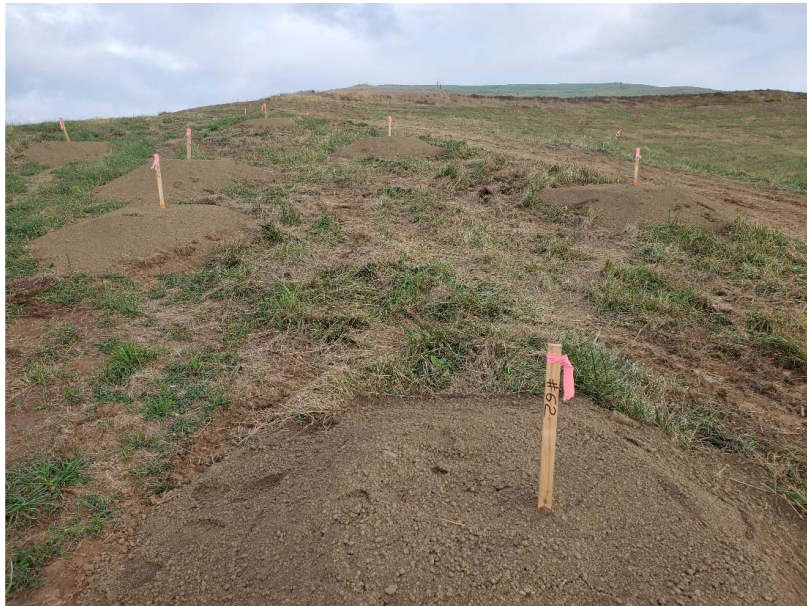
Photo 1 – Crown Excavating installed mounds of topsoil in the surveyed Phase 1 locations.

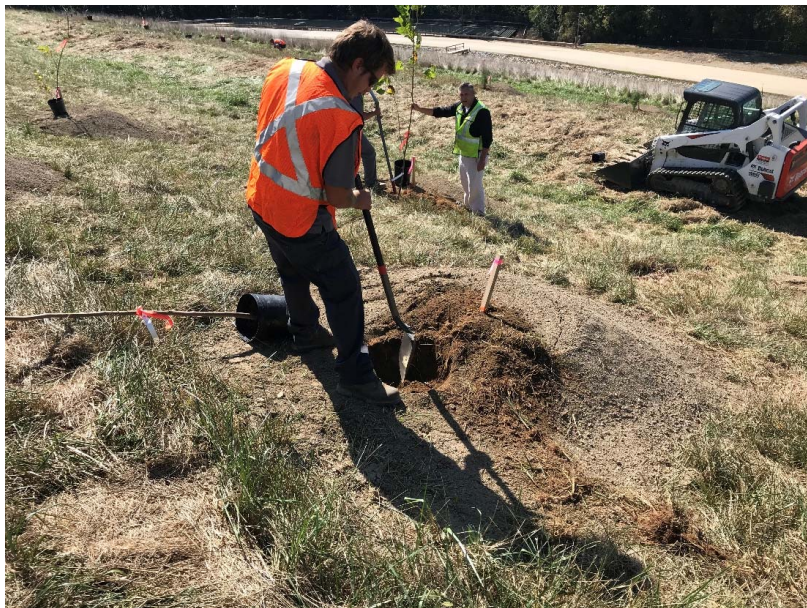
Photo 2 – Tomlinson Bomberger performing planting of the Phase 1 trees.
All trees were planted with hand tools and monitored for planting depth by ARM.

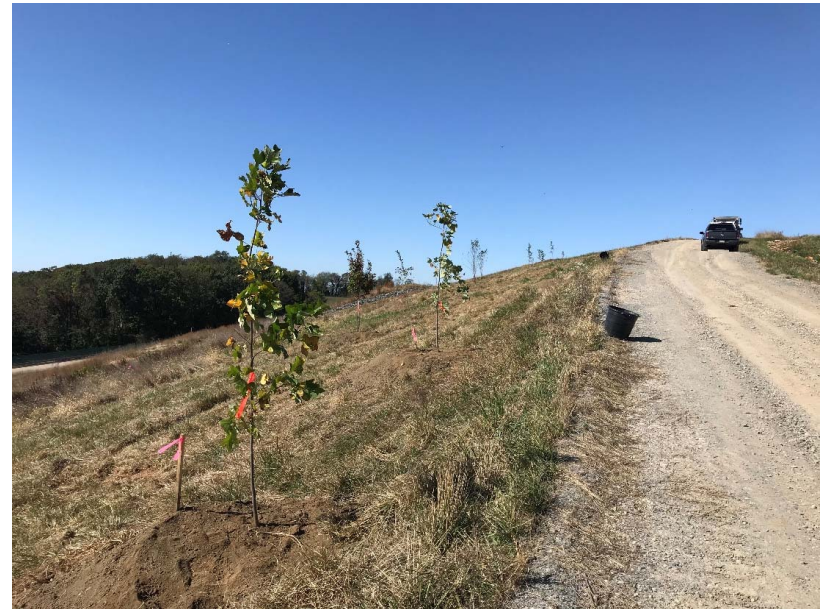
Photo 3 – Day 1 planting observation progress picture.

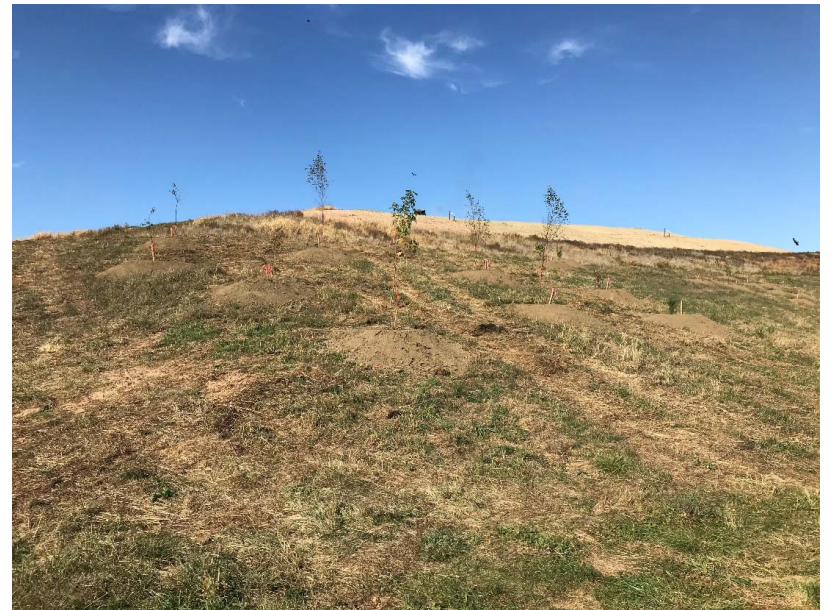
Photo 4 – Day 2 planting observation progress picture.

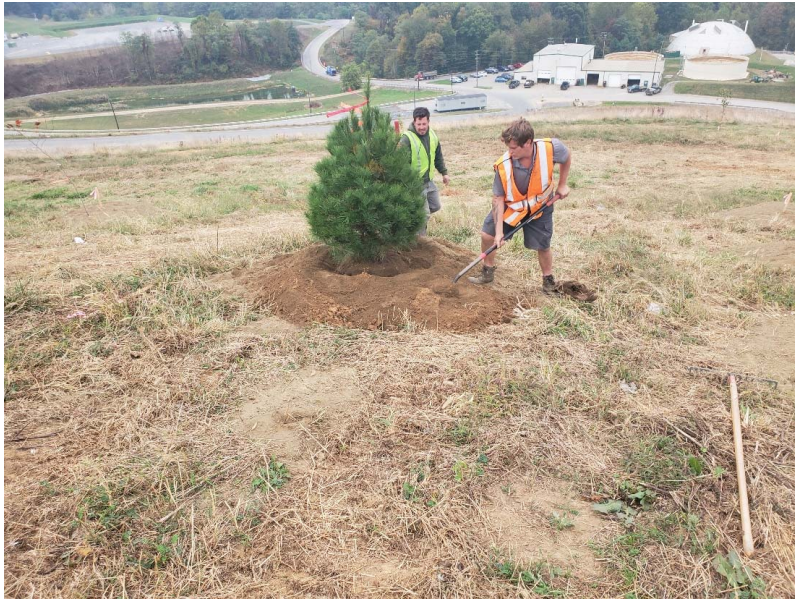
Photo 5 – Day 3 planting observation progress picture. The larger plant material was planted on Day 3.

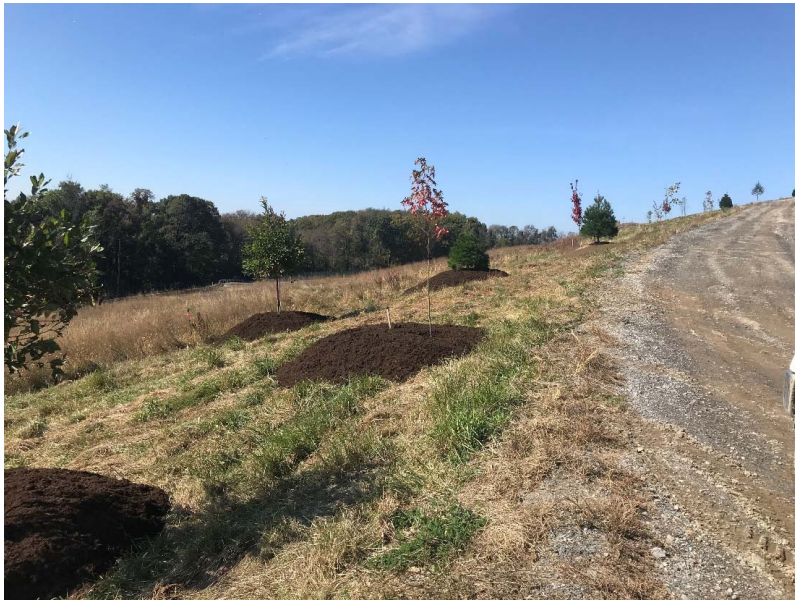
Photo 6 – Crown Excavating completed mulching around planted trees.

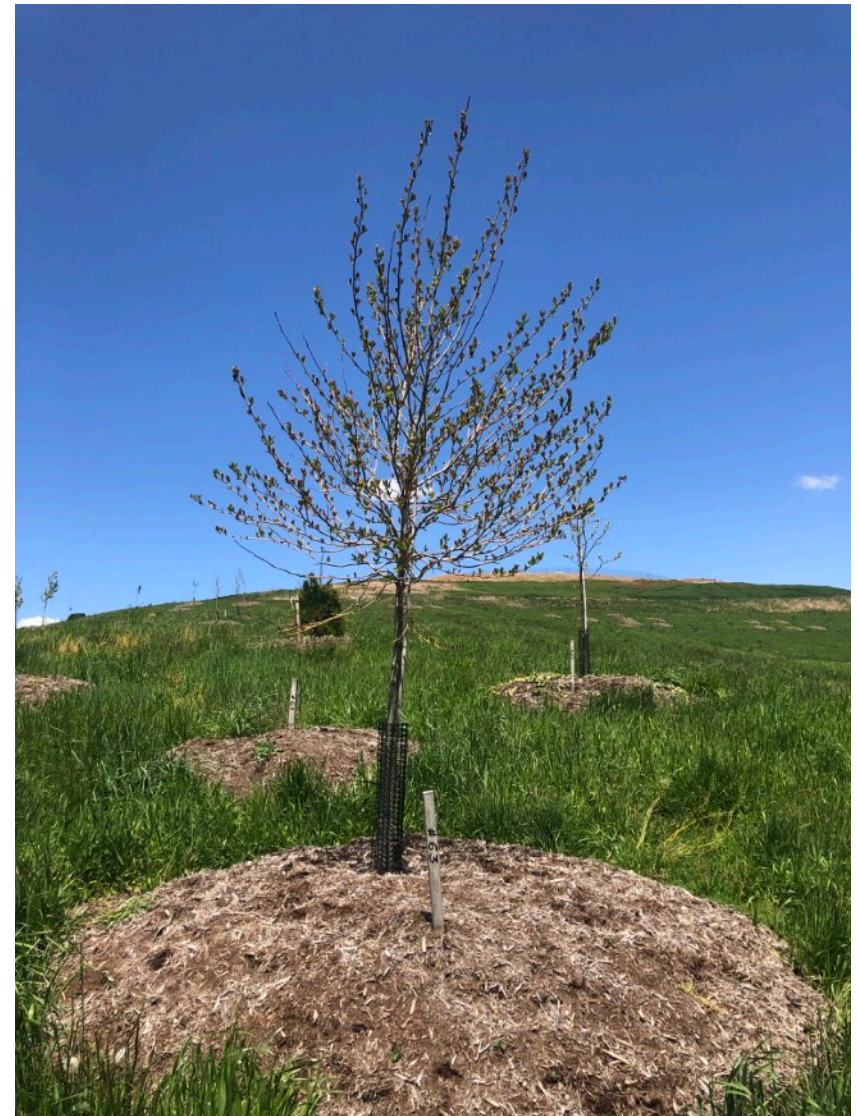
Photo 7 – A Black Gum tree. Mulch has faded becoming more natural. Note deer protection and tree identification stakes.

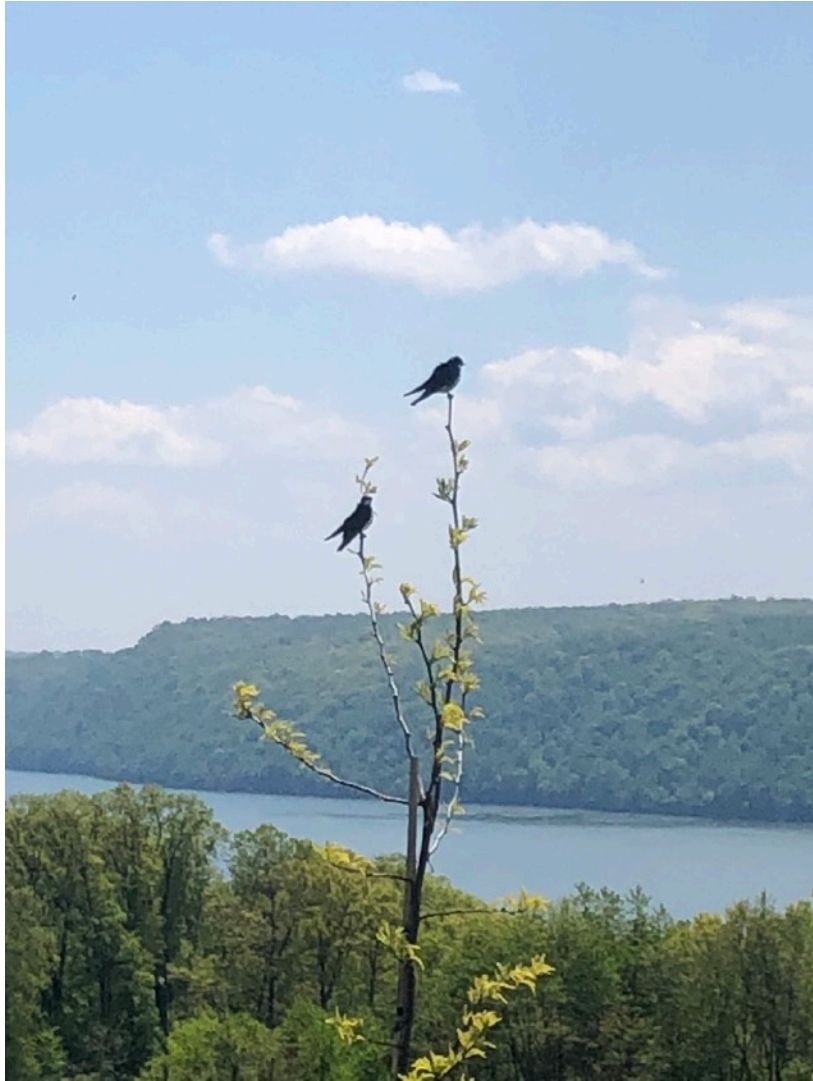
Photo 8– Frequently observed many birds utilizing new habitat.

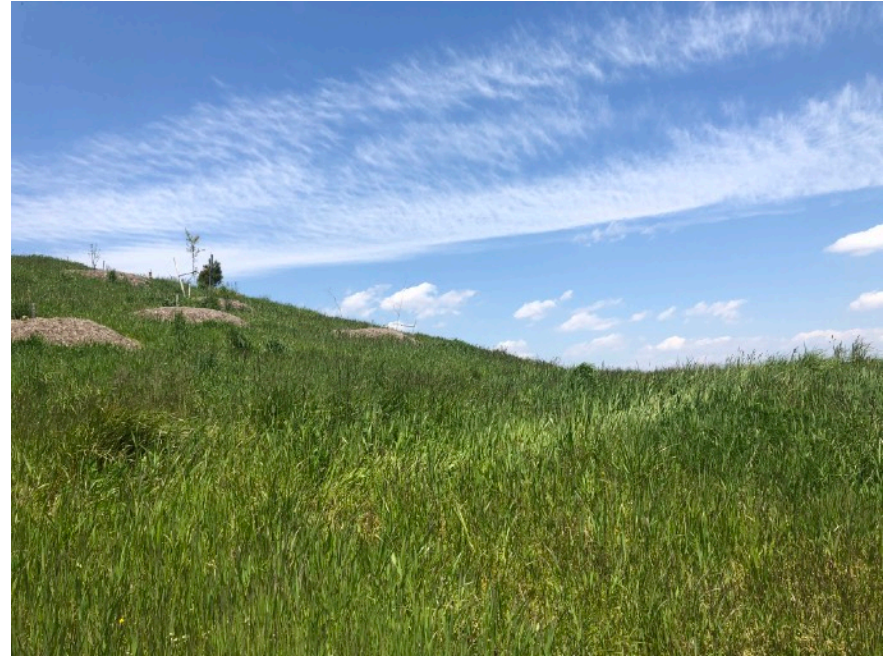
The natural succession area is doing quite well and has already softened the engineered appearance of the landfill (benching). The visual softening and textural diversity observed in 2019 and in 2020 should increase over time and continue to add a more natural appearance to the landfill slopes that blends into the surrounding landscape. No additional modifications or revisions are planned for the Stage 1 succession areas.

Photo 9 – Natural Succession beginning to soften engineered appearance of landfill benching.
